German and Polish Houses

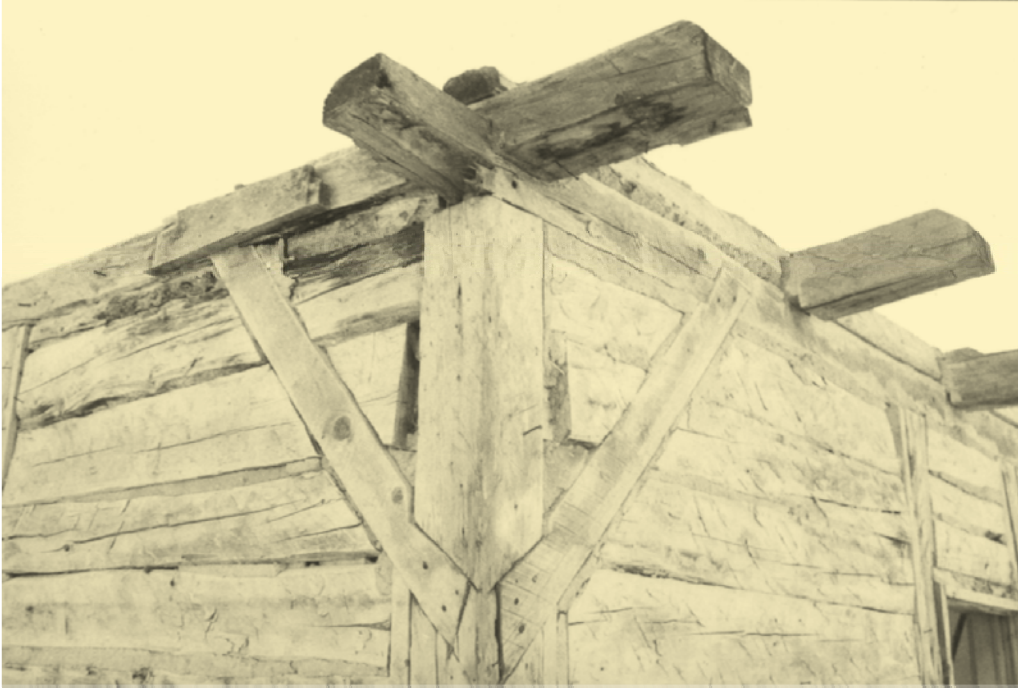
Figure 18

The corner bracing and the top plate-beam connections used in German post and fill construction encouraged some interesting detail work.

During the settlement of the Eastern Interlake area several rural districts were homesteaded by German-speaking immigrants whose language became dominant in the districts of Felsendorf, Haas, Berlo and Rosenburg. By 1915, largely due to poor soils, many of these settlers left the area to return to Europe or resettled in Saskatchewan. The few who did remain, especially in the Berlo district, built structures that are distinctively German. Like many Ukrainian buildings in surrounding areas the typical German house was a single storey gabled structure with a rectangular two or three room plan. Unlike the Ukrainian residences, the German houses had a north-south orientation with the entrance on the west side. The use of post and fill construction, rather than horizontal log construction, also distinguishes the typical German house (Figure 18).

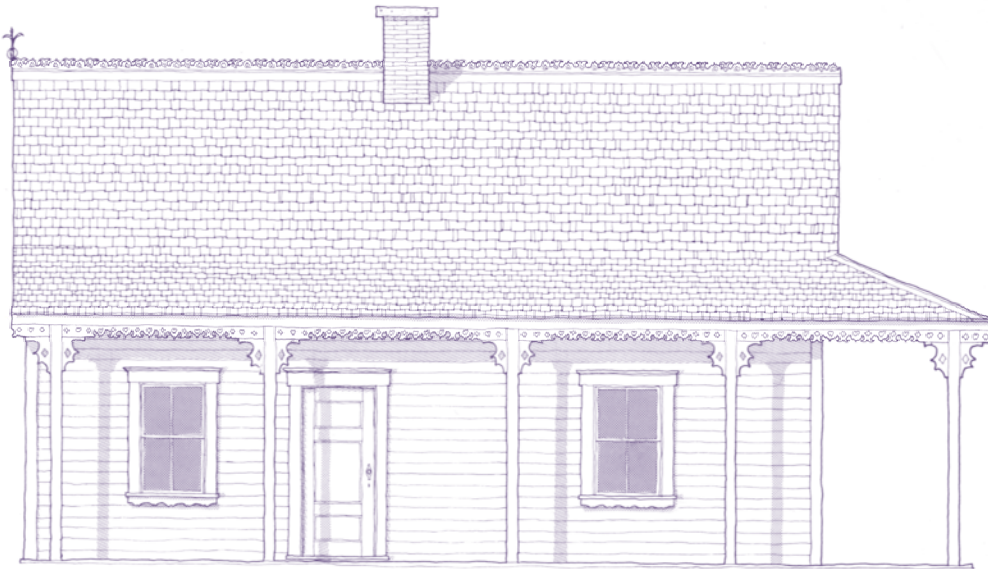
Figure 19

The roof cresting, window and door mouldings and the intricate verandah detailing were typical elements on the German houses in the Eastern Interlake.

Finally, a prominent flared eave projection along the west and south faces formed a large verandah that was usually supported by rectangular posts. Subsequently these houses were often sheathed with wood siding, extended with a lean-to addition and upper storey bedroom and embellished with decorative mouldings (Figure 19).

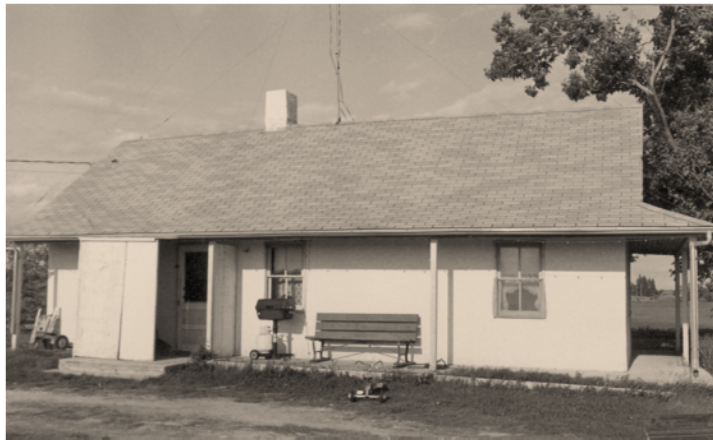
Figure 20

Gottfried house, SE 27-20-3E, ca. 1910. The eave projection and the north south orientation with a western entrance are evident here.

Only three log houses and three log farm buildings remain in the Berlo area. The Gottfried house, at SE 27-20-3E is the best German house remaining, even though it has been altered with a new roof, a stucco finish and the removal of most decorative elements (Figure 20).

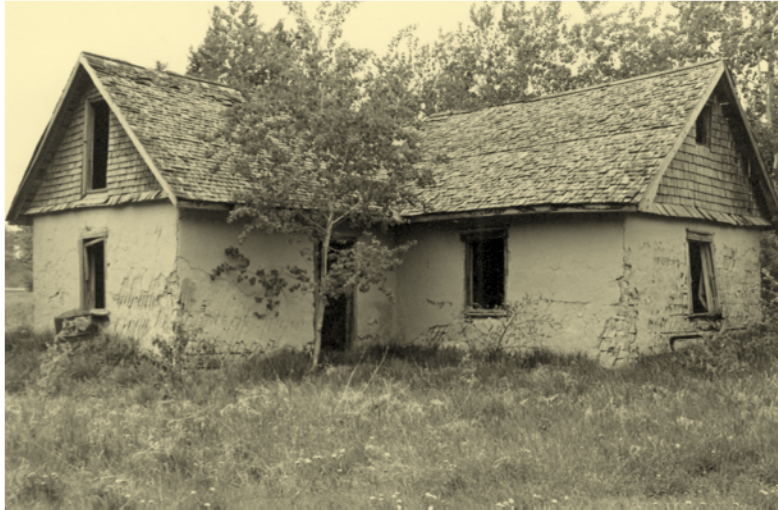
Figure 21

Polish house, SE 27-19-3E, ca. 1915. The logs used to construct this house in the Gimli area were joined with dovetail notches. Purchase laths were nailed to the walls and a thick mud plaster coating was applied.

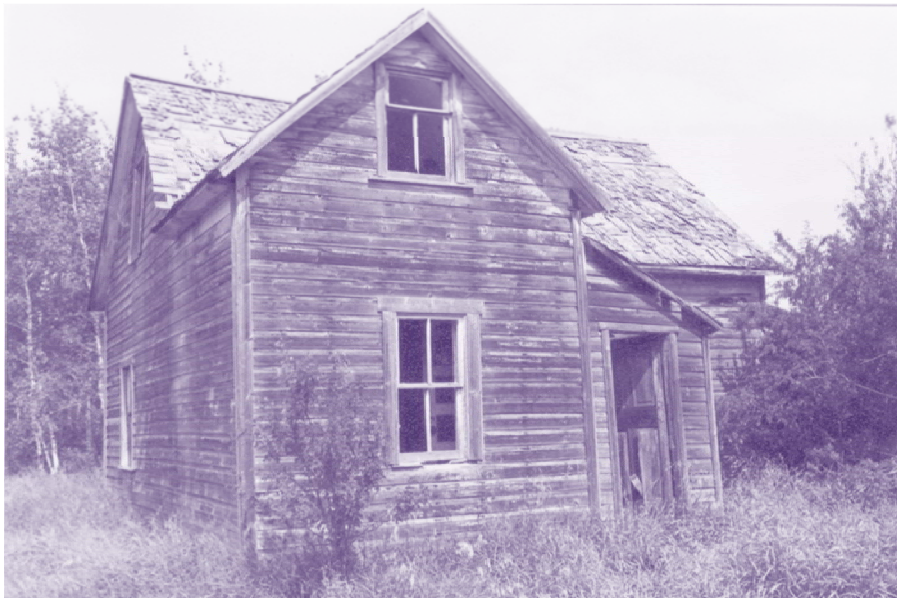
Figure 22

Barylski residence, SE 4-25-2E, ca. 1920.

In the Jaroslaw district, where there were more Polish settlers, a distinctive house was common at one time. These 1 1/2 storey gabled structures in the planning district were often covered on both sides of the wall with a thin mud plaster coating. Both of these kinds of houses, like the Ukrainian and German houses, were often enlarged and improved. A second storey was sometimes added, the whole structure was typically sheathed with wooden siding and a verandah frequently graced the entrance (Figure 22).
